RECOVERY AND RECONSTRUCTION OF THE COLLAPSED STEEL BRIDGE OVER RIVER OMO IN ETHIOPIA

Brief: Recovery of the collapsed steel bridge in this remote part of the Ethiopia presented a serious challenge both from the engineering, design and execution point of view. Sophisticated heavy lifting equipment supplied by VSL (Switzerland) and DNEC engineering design effort were met with a limited locally available material and human resources to bring this project to success. With the careful engineering approach, structures that were never meant to be used in such configurations were pushed to the limit with minimum additional strengthening. Operating with the real measured loads and controlling the risk of unknown loads and events, combined with the wild nature, made this job even more challenging. The operation was conducted in three steps; bridge recovery from the water, repair of the bridge damaged section and final bridge launching to its designed position. From the engineering point of view the project was a complete success, and the clean safety record of the operation made all of us even more proud.

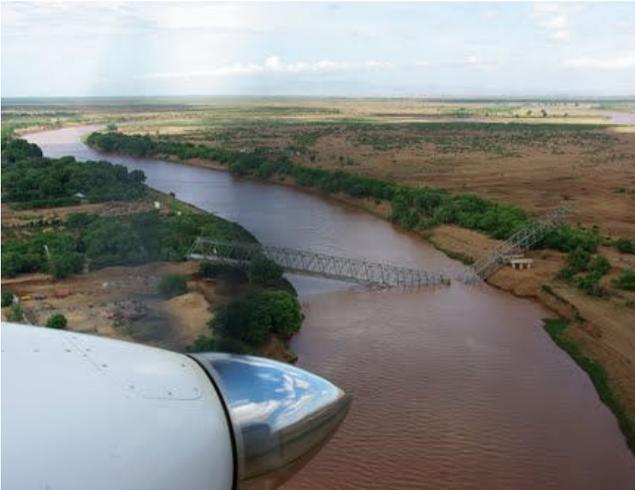
between the nose and the truss failed causing the truss to rotate around its support at Jinka pier. The collapse was inevitable and the rotation stopped only after the bottom chord front nodes reached the river bed.

*Slika 2: Izgled mosta neposredno nakon kolapsa
(Photo 2: View of the bridge immediately after collapse)*

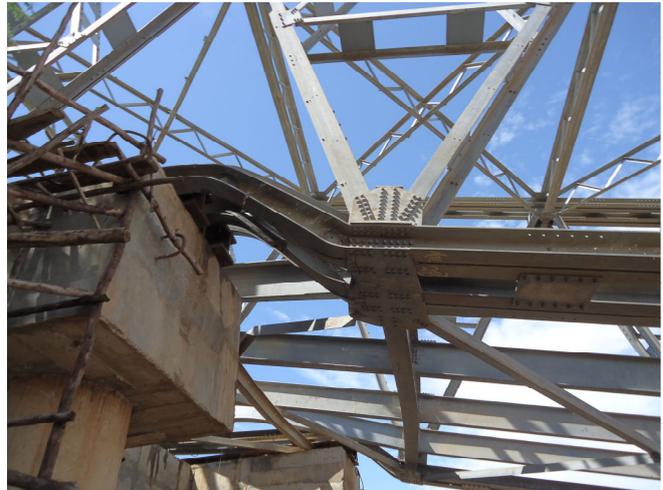
*Slika 3: Oštećenje elemenata donjeg pojasa rešetke na
Džinka oporcu
(Photo 3: Extent of the damage of bottom chord joints at
Jinka pier)*

During the months after the bridge collapse took place, the truss section that submerged into the river was moved downstream by the river flow causing a horizontal shift of the bridge and further serious damage of bottom chord and secondary members that were still supporting the truss on the Jinka pier. The extent of the damage required modification of methodology and substantial repair of the truss bottom chord members prior to re-launching. As a consequence the recovery job that was already quite demanding became even a greater engineering challenge.

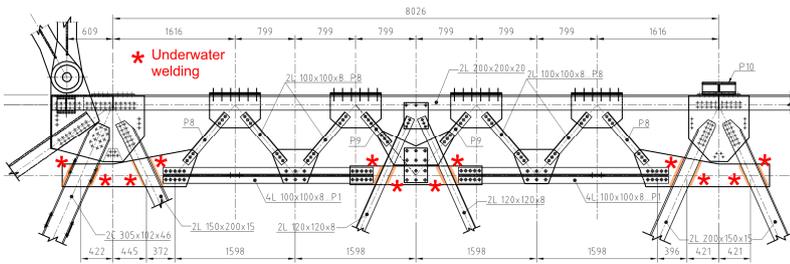
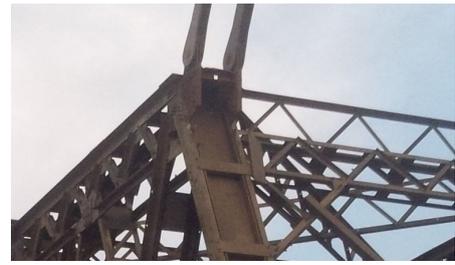
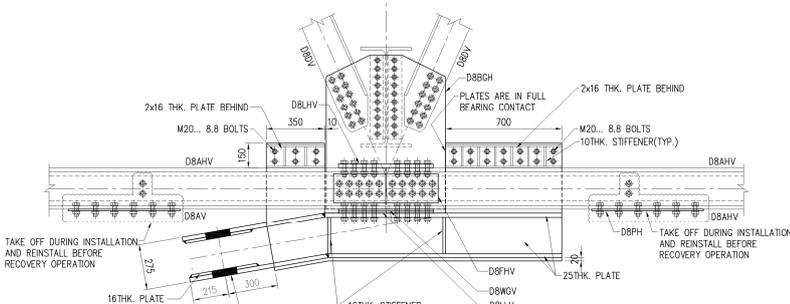
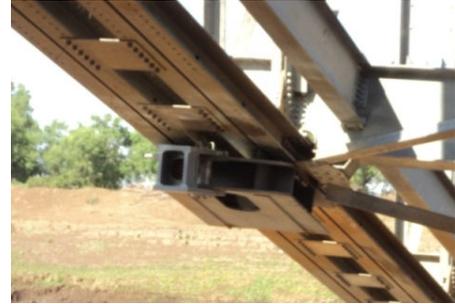
Slika 9: Detalji veza ojačanja rešetke mosta na vezi glavnog kabla (gore) i kontra zatege (dole)
 (Photo 9: Details of truss strengthening at main cable connection (above) and tie-back connection (below))

Connection of main lifting cables and retainer cables to the bridge steel structure had to be carefully assessed as the bridge had not originally been designed for such load application. Strengthening of the truss top chord near the pulling cables connection point required additional members forming a local truss shape and careful detailing to allow installation without dismantling the bridge joints. In few instances installation of additional members required underwater welding in the river with zero visibility. The Client has contracted this task to Indian based underwater welders who successfully completed this challenging work.

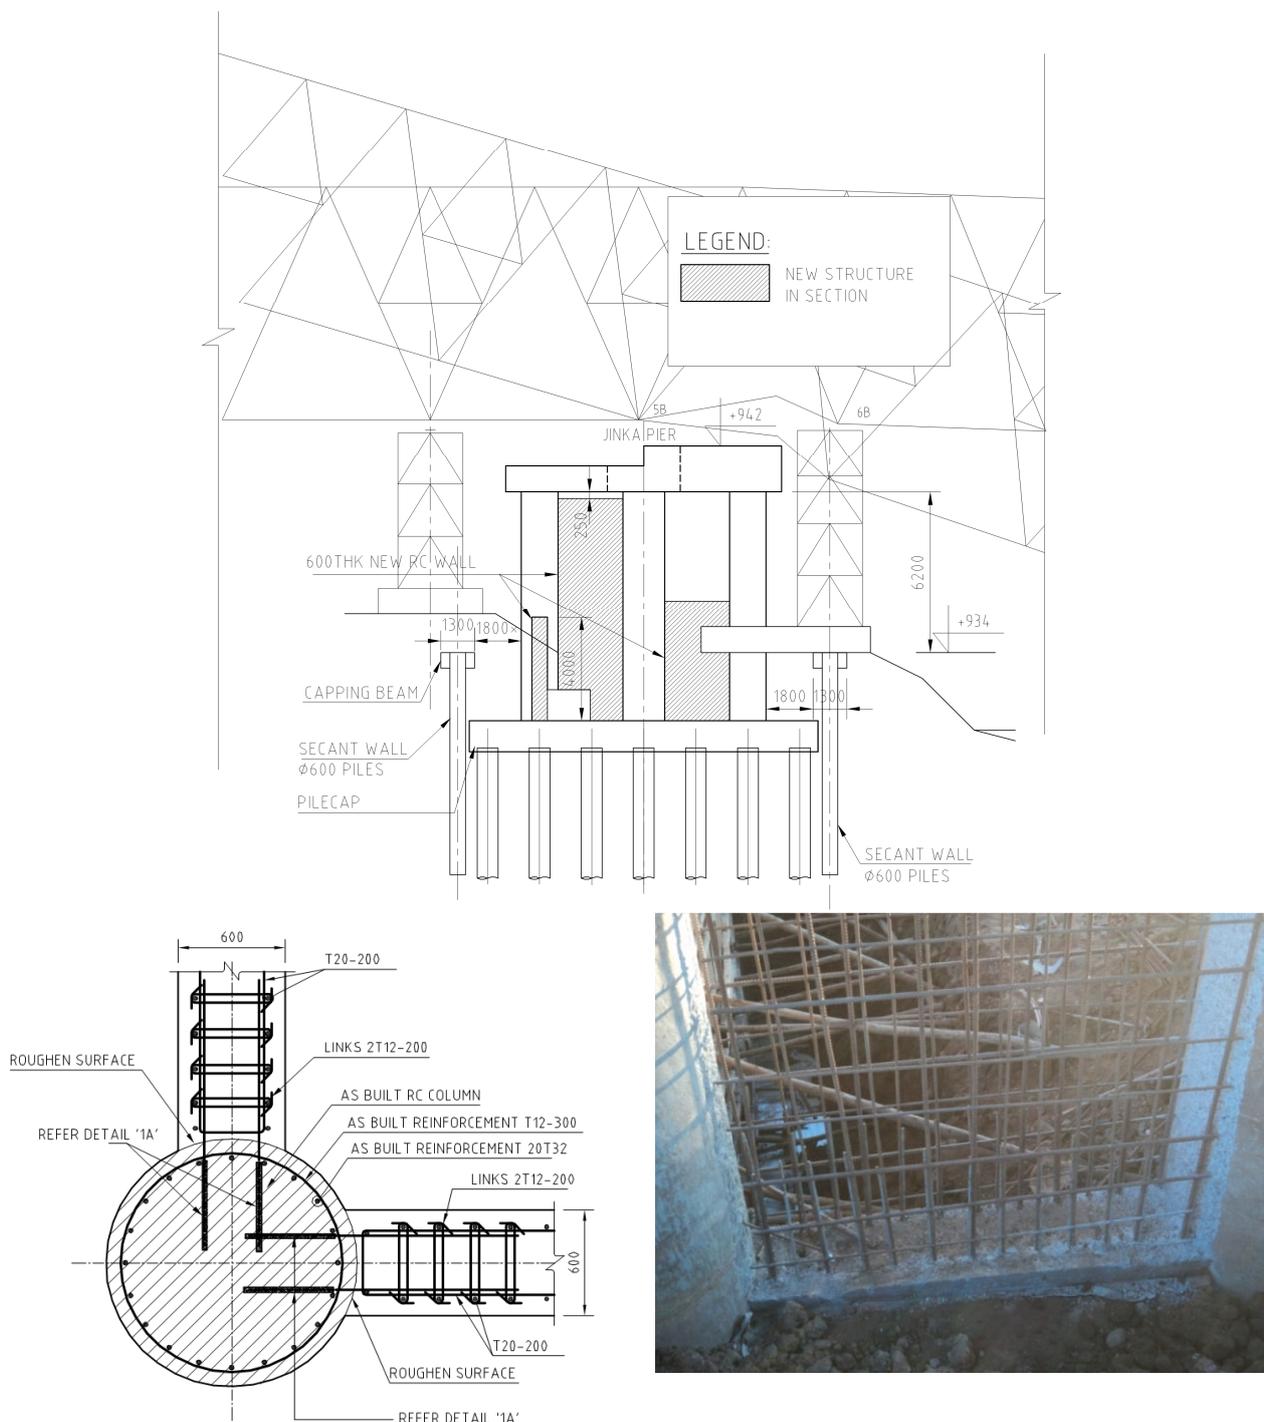
*Slika 12: Crteži i slike ojačanja Džinka oporca
(Photo 12: Drawings and photos of Jinka abutment strengthening)*

Towers support and cable ground anchorage foundations were designed with limited information on soil parameters. A particular challenge was the reinforcement of the Jinka abutment in order to withstand retainer reactions. The columns of the pier were additionally stiffened with the shear wall in-between the piers columns to limit pier columns bending.

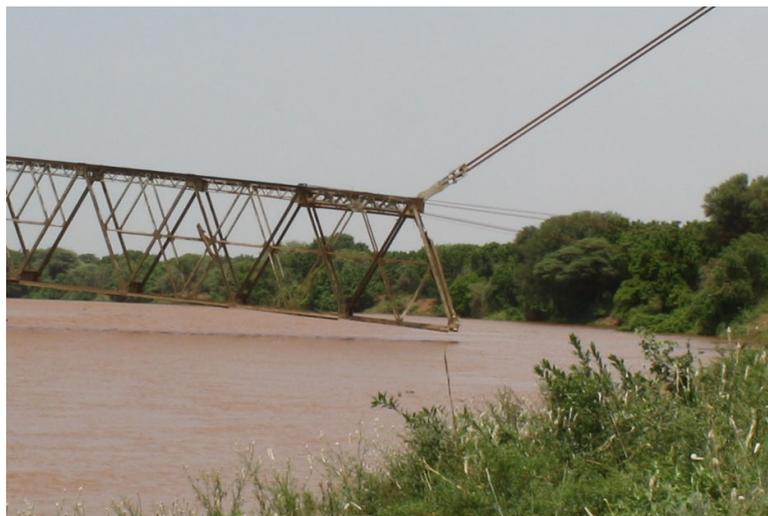
Slika 14: Most posle uspešnog izvlačenja iz vode
 (Photo 14: Bridge after successful recovery from the water)

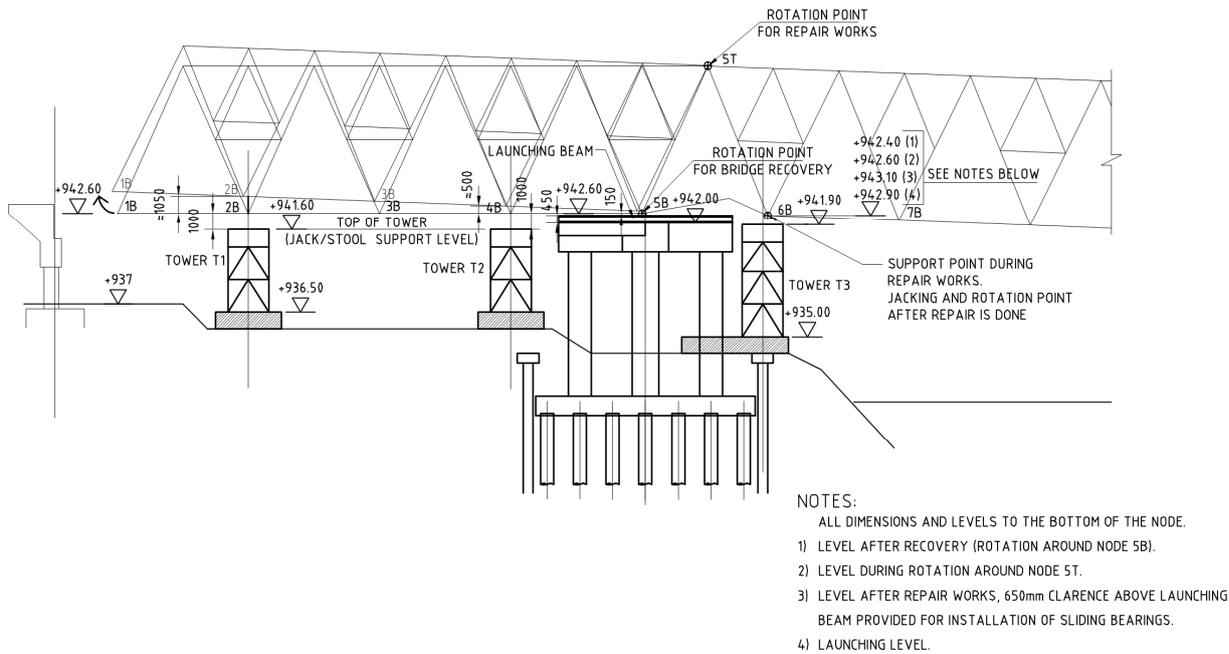
Bridge top chord joint 5T indicated as rotation point was carefully studied and the implication of the bridge rotation to the potential deformation of its elements assessed. It was concluded that the rotation induced stresses and elongations were within design limits. Majority of the rotation was absorbed by the bolts rotation at the standard oversized holes.

Slika 15: Vertikalno poravnanje
(Photo 15: Vertical alignment)

After the bridge was recovered from the water it was brought to the near-horizontal elevation and rotated horizontally to align with the designed centre line. At this point of time, jacks were mechanically locked. In order to allow for the bridge to be straightened the deformed section of the bridge needed to rotate around top chord joint 5T for approximately 3°. For this operation bridge section from joint 1T to joint 5T needed to be independently supported by the temporary towers T1 and T2 and main span of the bridge beyond the joint 5T to be supported at temporary tower T3. This load transfer operation allowed the bottom chord damaged members to be removed and truss end free to rotate.

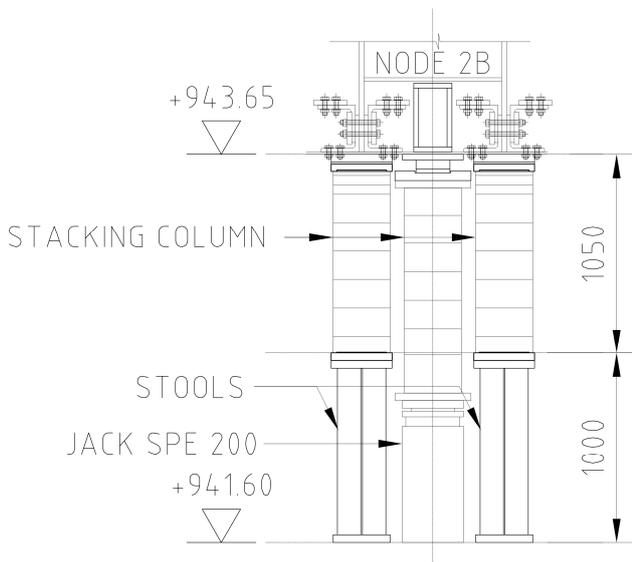
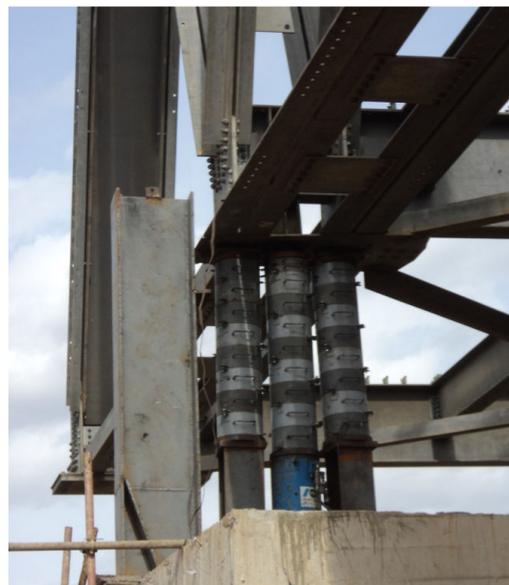
Slika 16: Crtež i slika čvora 2B
(Photo 16: Drawing and photo of node 2B)

Rotation of the bridge segment was conducted by staged jack-up operations from the towers T1 and T2 using conventional hydraulic jacks. Maximum height of the free standing jacks' piston and packing was estimated to reach 1m at tower T1. Stability of the bridge segment was provided by steel shoring using fabricated stopper beams installed at the top of the temporary towers. Damaged elements were removed and replaced using conventional tools.
