RECOVERY AND RECONSTRUCTION OF THE COLLAPSED STEEL BRIDGE OVER RIVER OMO IN ETHIOPIA

Brief: Recovery of the collapsed steel bridge in this remote part of the Ethiopia presented a serious challenge both from the engineering, design and execution point of view. Sophisticated heavy lifting equipment supplied by VSL (Switzerland) and DNEC engineering design effort were met with a limited locally available material and human resources to bring this project to success. With the careful engineering approach, structures that were never meant to be used in such configurations were pushed to the limit with minimum additional strengthening. Operating with the real measured loads and controlling the risk of unknown loads and events, combined with the wild nature, made this job even more challenging. The operation was conducted in three steps; bridge recovery from the water, repair of the bridge damaged section and final bridge launching to its designed position. From the engineering point of view the project was a complete success, and the clean safety record of the operation made all of us even more proud.

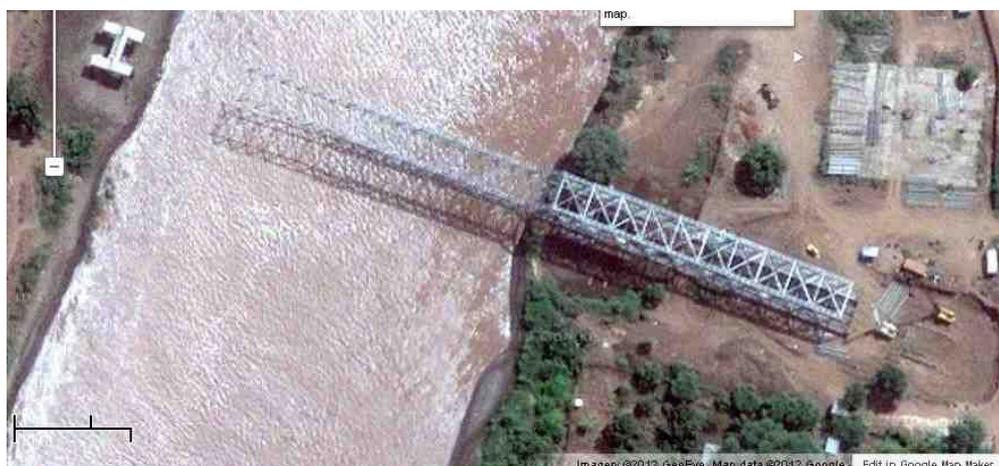
*Slika 1: Most u privremenoj fazi inicijalnog navlačenja pre kolapsa
(Photo 1: Bridge in the temporary phase of initial launching before collapse)*

Under unclear circumstances, just as the launching nose has reached the Kelem side the connection

between the nose and the truss failed causing the truss to rotate around its support at Jinka pier. The collapse was inevitable and the rotation stopped only after the bottom chord front nodes reached the river bed.

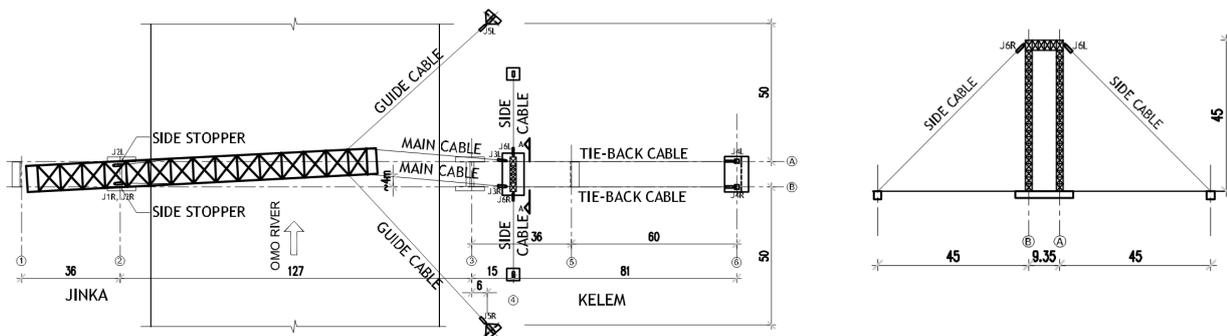
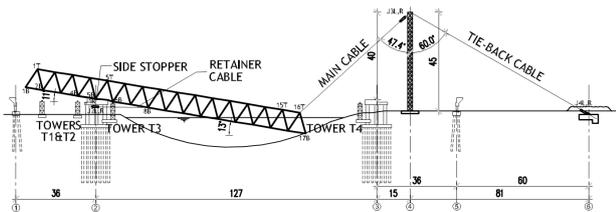
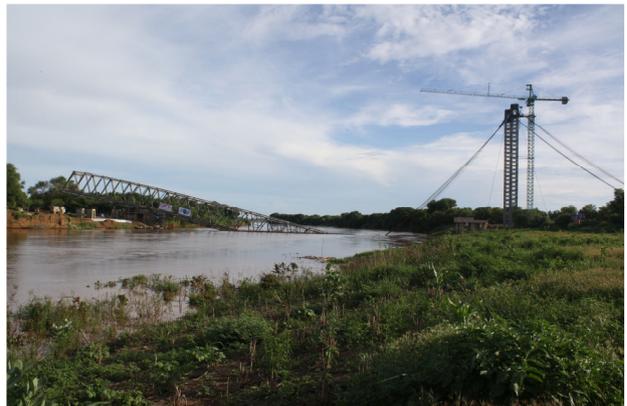
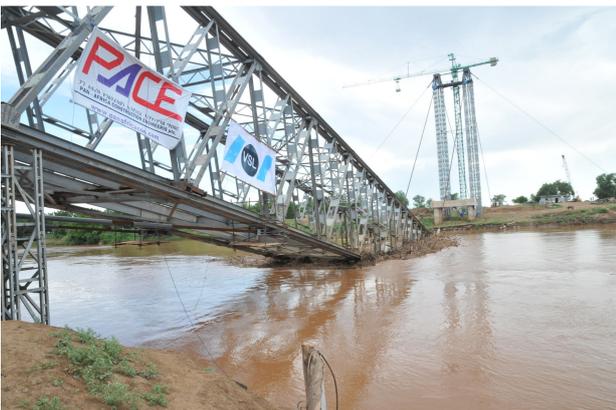
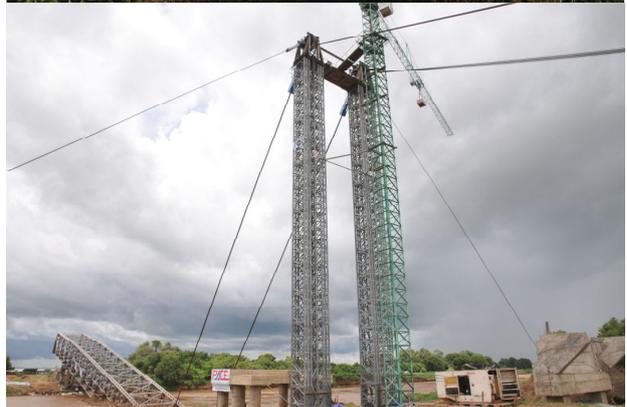
Slika 4: Pozicioniranje privremenih elemenata za operaciju izvlačenja mosta iz reke
(Photo 4: Layout of temporary elements positioned for the recovery operation)

After discussing several options, the following option prevailed. It was decided to recover and launch the bridge using 45m tall temporary towers constructed on the Kelem bank tied back to the mass concrete foundation constructed at the back of the temporary tower. Towers were stabilised for the sideways movement by another pair of side cables. The lifting force, originated by the main cable inclination, is retained by the Retaining cable connected to the abutment on the Jinka bank. Side stopper system was provided at the Jinka pier to prevent bridge side movement over the pier.

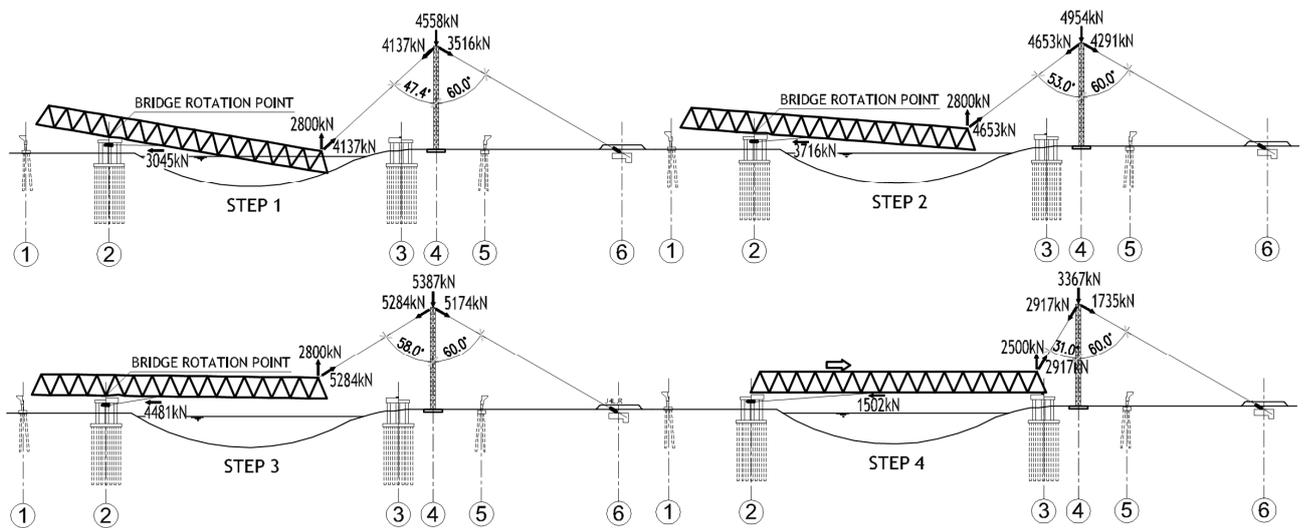
Slika 5: Projektovane sile u glavnim kablovima (parovi kablova) tokom operacije izvlačenja i navlačenja
(Photo 5: Calculated forces in pairs of main cables during the recovery and launching operation)

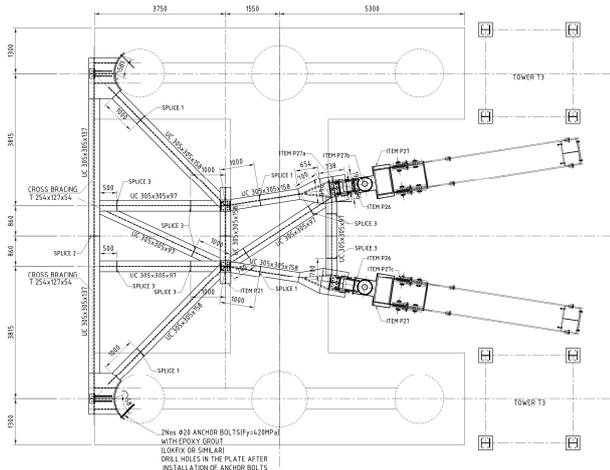
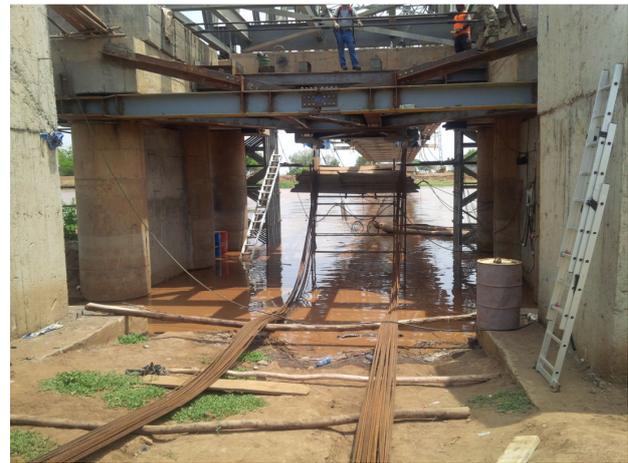
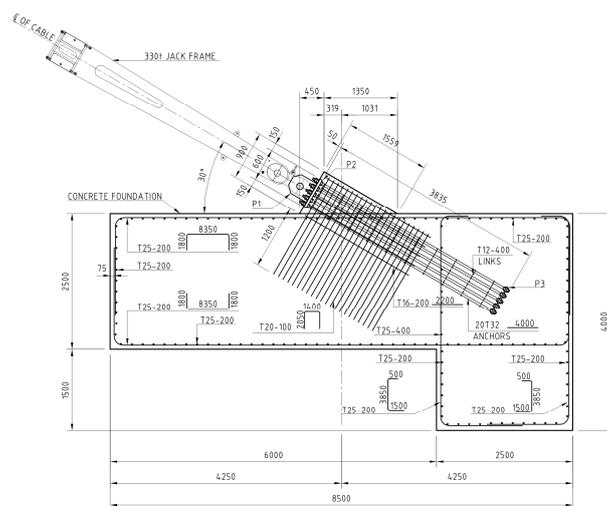
Slika 10: Detalji ankerovanja kontra zatege na Džinka obali (gore) i temelja kontra zatege na Kelem obali (dole)
 (Photo 10: Anchoring details for retainer on Jinka bank (above) and foundation of tie-back cable at Kelem bank (below))

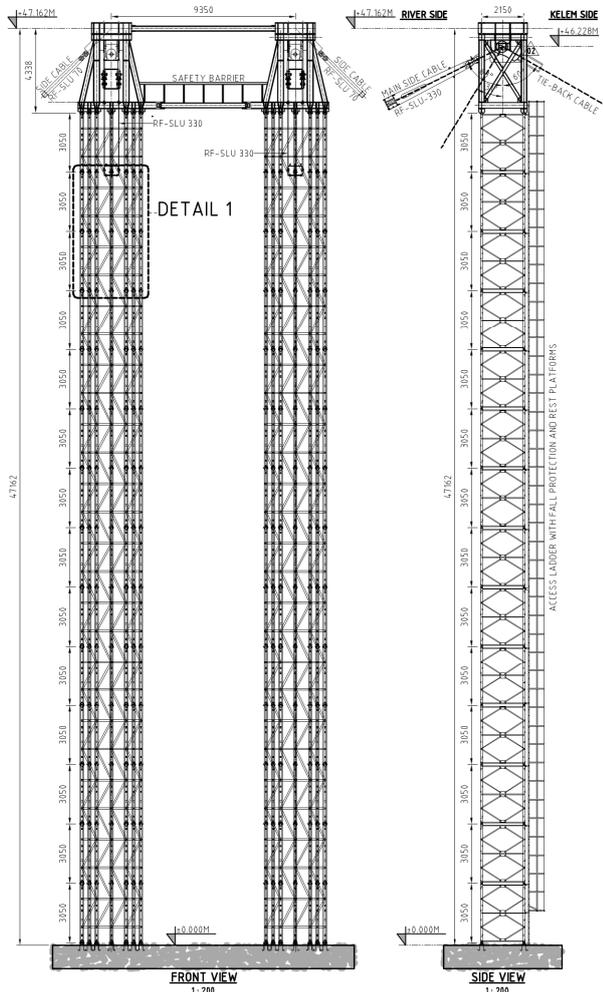
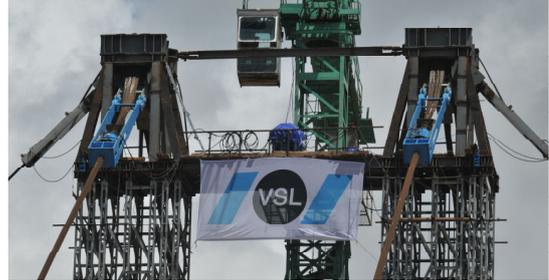
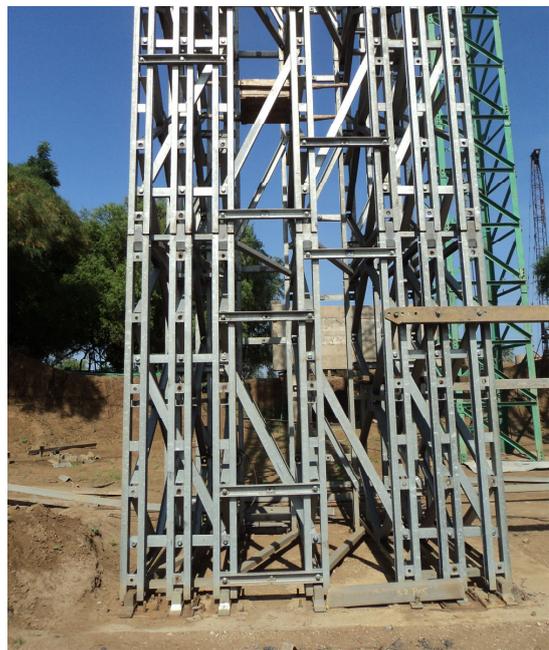
Slika 11: Crteži i slike jarma i detalji ramova na vrhu jarma
(Photo 11: Drawings and photos of tower and its top)

Additionally, the Client wanted to use locally available Bailey bridge sections for the 45m tall main tower construction. Incorporation of available Bailey bridge sections into the tower formation required additional interconnecting bracings. Top parts of the main towers were separately detailed. The detail of tower top frame needed to allow a concentric connection of the main cable, tie-back cable and the side cable in a very congested area. Additionally top tower frame had to be detailed in a way to provide uniform distribution of the loads to the multiple legs of the main tower.

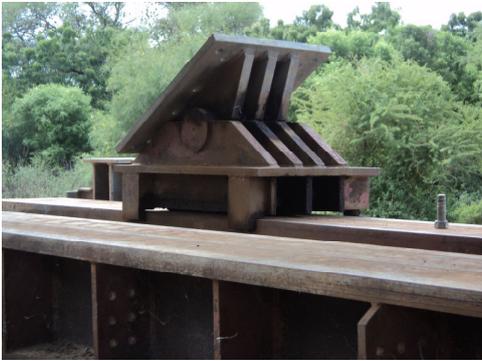
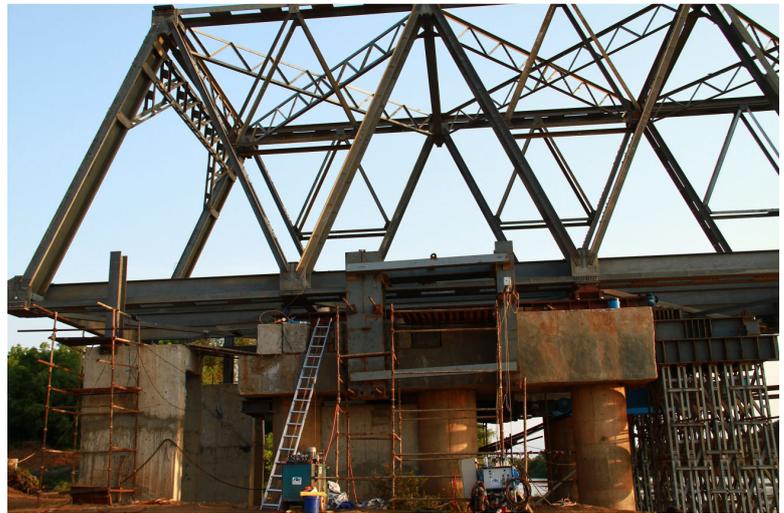
*Slika 17: Slika pokretnog ležišta i klizanje na Džinka osloncu
(Photo 17: Photos of sliding roller and its sliding at Jinka pier)*

After bridge repair work has been completed, the preparation for bridge launching was ready to commence. The original sliding beam and the pair of undamaged sliding rollers were used for the bridge sliding over the Jinka pier. The bridge was subsequently offloaded from the towers T1, T2 and T3 onto the sliding bearing and the bridge was set for final launching.
